ST. ANTHONY FALLS
BRIDGE REPLACEMENT

St. Anthony Falls I-35W Bridge Replacement

ASHE National Conference
June 13, 2014

Dustin Thomas, P.E.
I-35W Bridge Construction Engineer

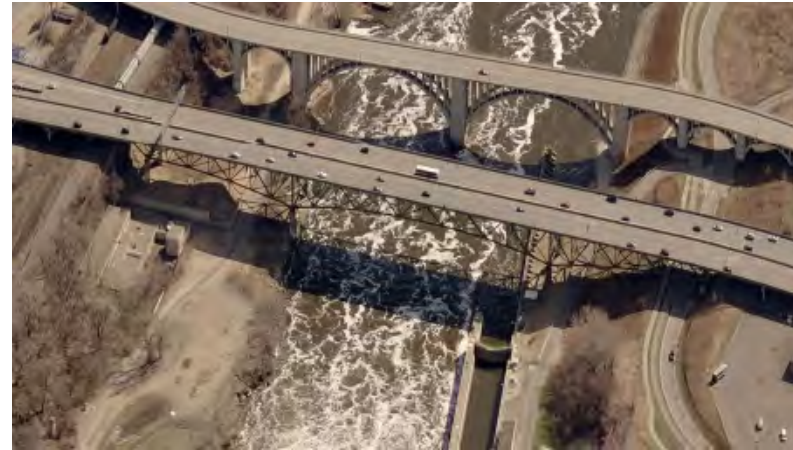
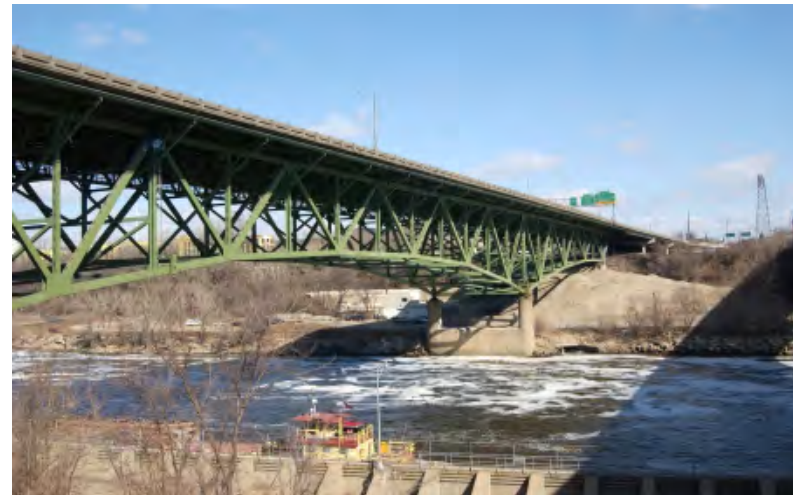
The Former Bridge - 9340

- Opened to traffic in 1967
- Steel truss bridge design
- Fracture critical bridge
 - If certain components fail, bridge can fail
- Bridge and Roadway Repair Project Underway at time of collapse

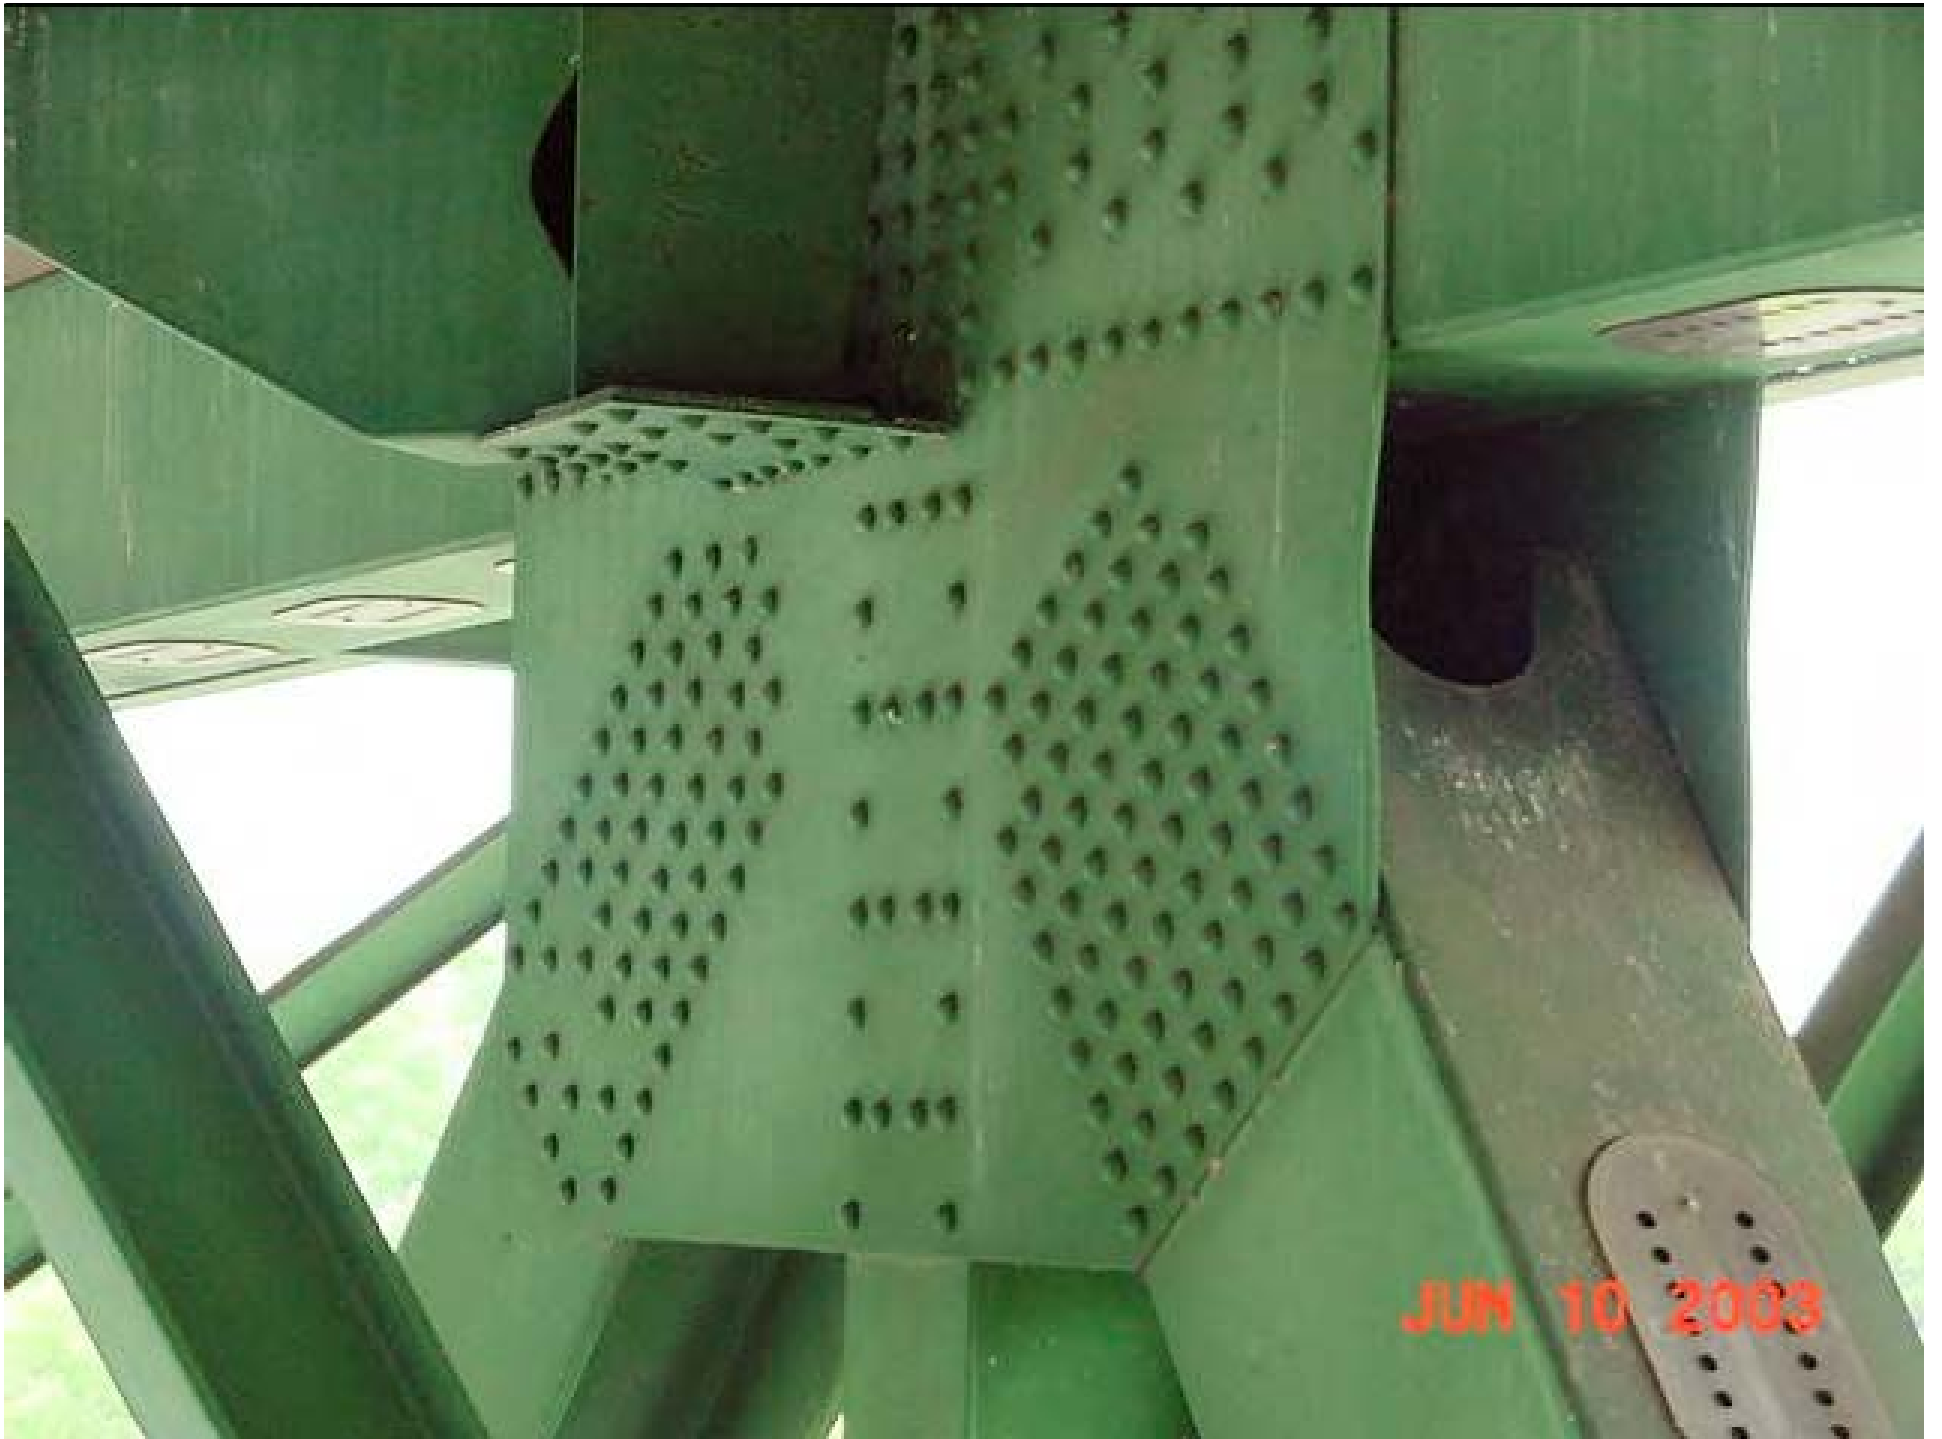
- 1 3/8" thick gusset plate (100 ksi) → 2 of 29 gusset plates
- 1" thick gusset plate (50 ksi) → 13 of 29 gusset plates
- 5/8" thick gusset plate (50 ksi) → 4 of 29 gusset plates
- ➔ ■ 1/2" thick gusset plate (50 ksi) → 10 of 29 gusset plates

- Collapse resulted due to inadequate load capacity of U10 gusset plates
- The design error was not initially detected during reviews by the design consultant
- The design error remained undetected through subsequent load ratings and through annual bridge inspections.

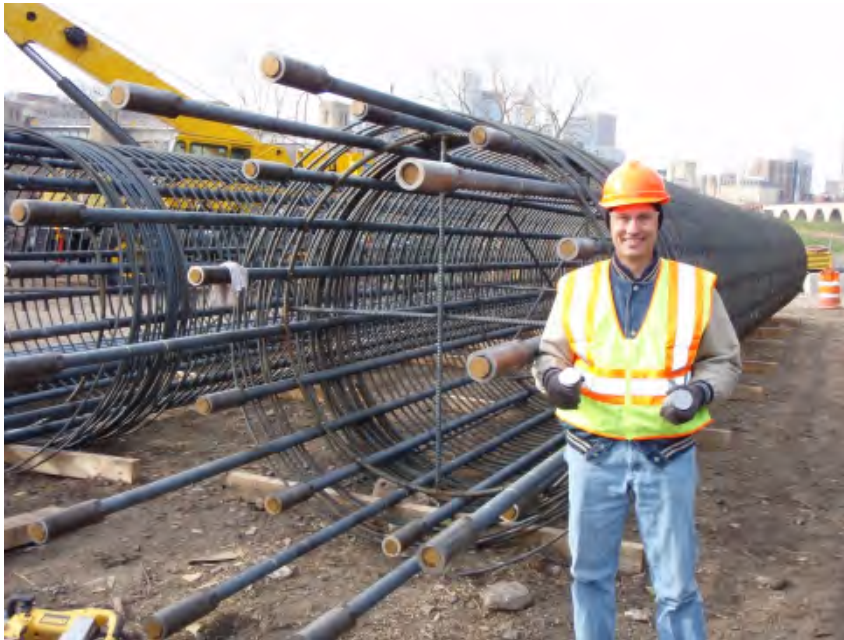
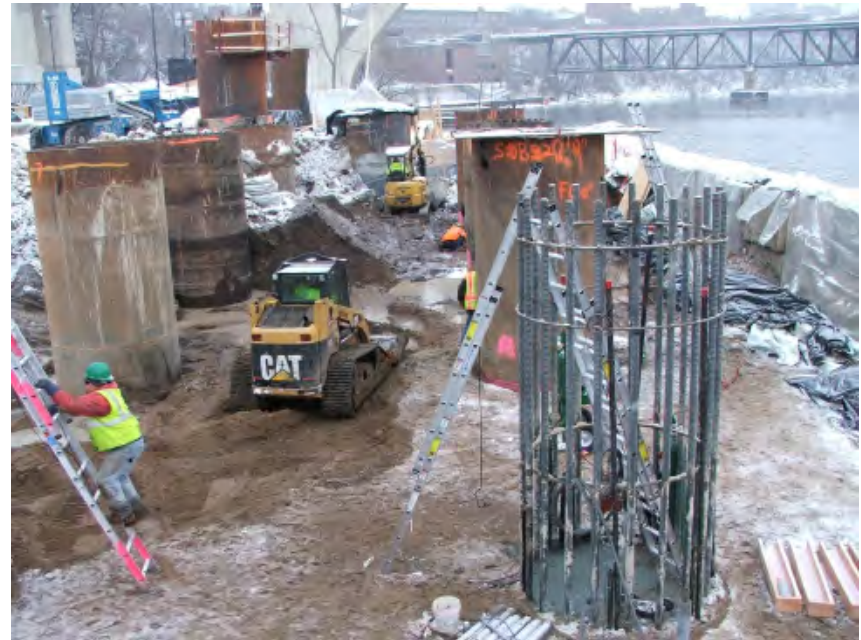
Drilled Shaft Construction

Pier #3

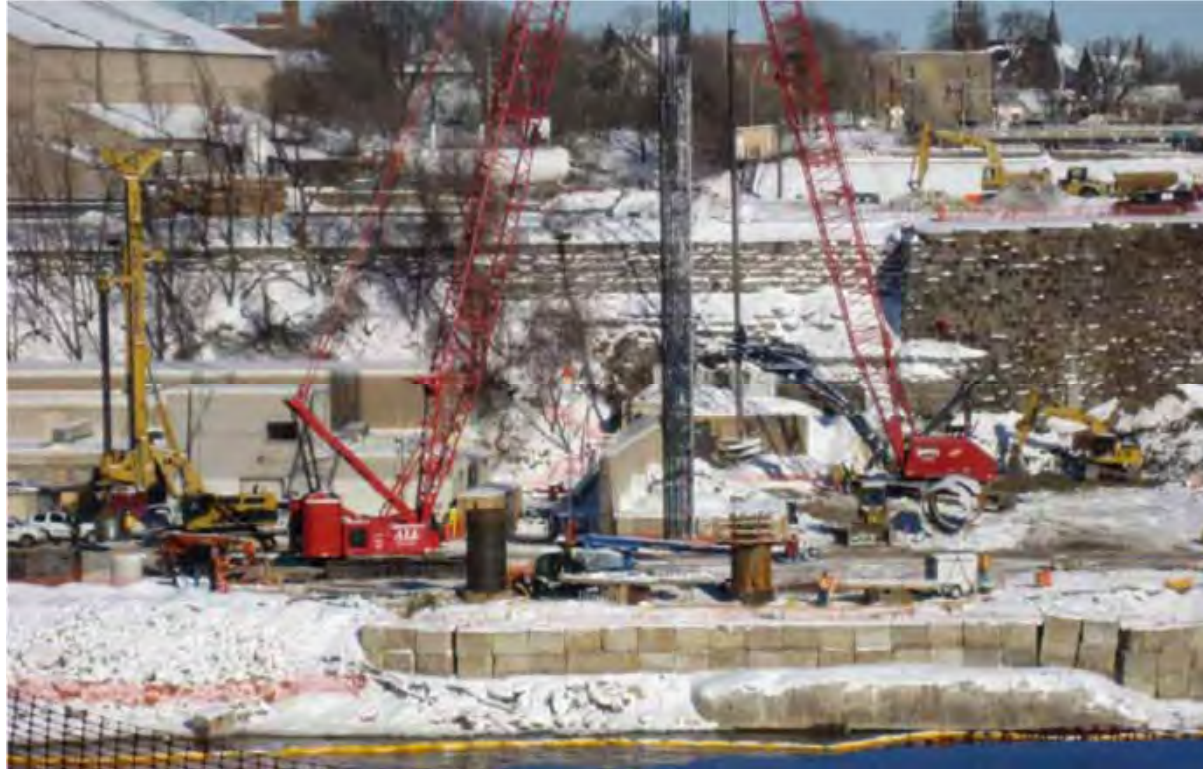
Drilled Shaft Foundations

**90' Average Length
Socketed into Rock**

- Performance Specifications
 - Impacts on Schedule and Quality
 - Strength, Permeability, Chloride resistance
 - Slag, Fly ash, Micro Silica
- Self Consolidating Concrete
 - Primarily used for drilled shafts
 - Volumetric Modifying Agents (VMA)
 - Helped prevent segregation in mix
- Contractor and Supplier Innovation
 - Solved past performance issues
 - Composite Gradations
 - Paving Mix includes incentives for well graded
 - Developed mix designs
 - 45 mix designs
 - Ex: 365 lbs slag, 98 lbs fly ash, 82 lbs portland
 - Silica Fume in Superstructure (approx. 3% by vol)
 - Used high range water reducing agents and retarders
 - Multiple test pours and mock ups

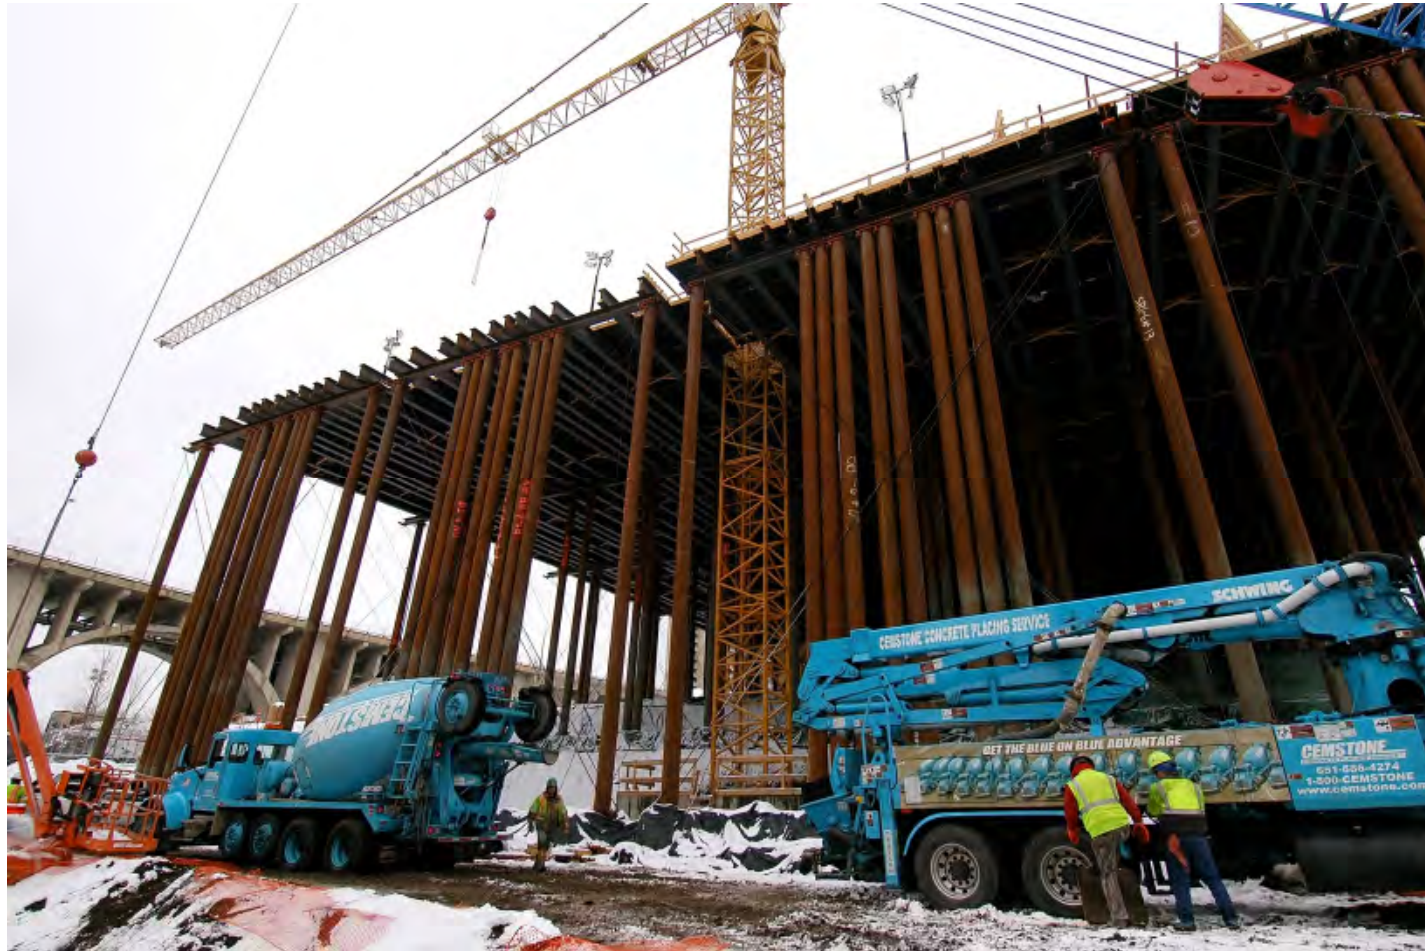
Falsework

South side falsework

Apr. 1, 2008

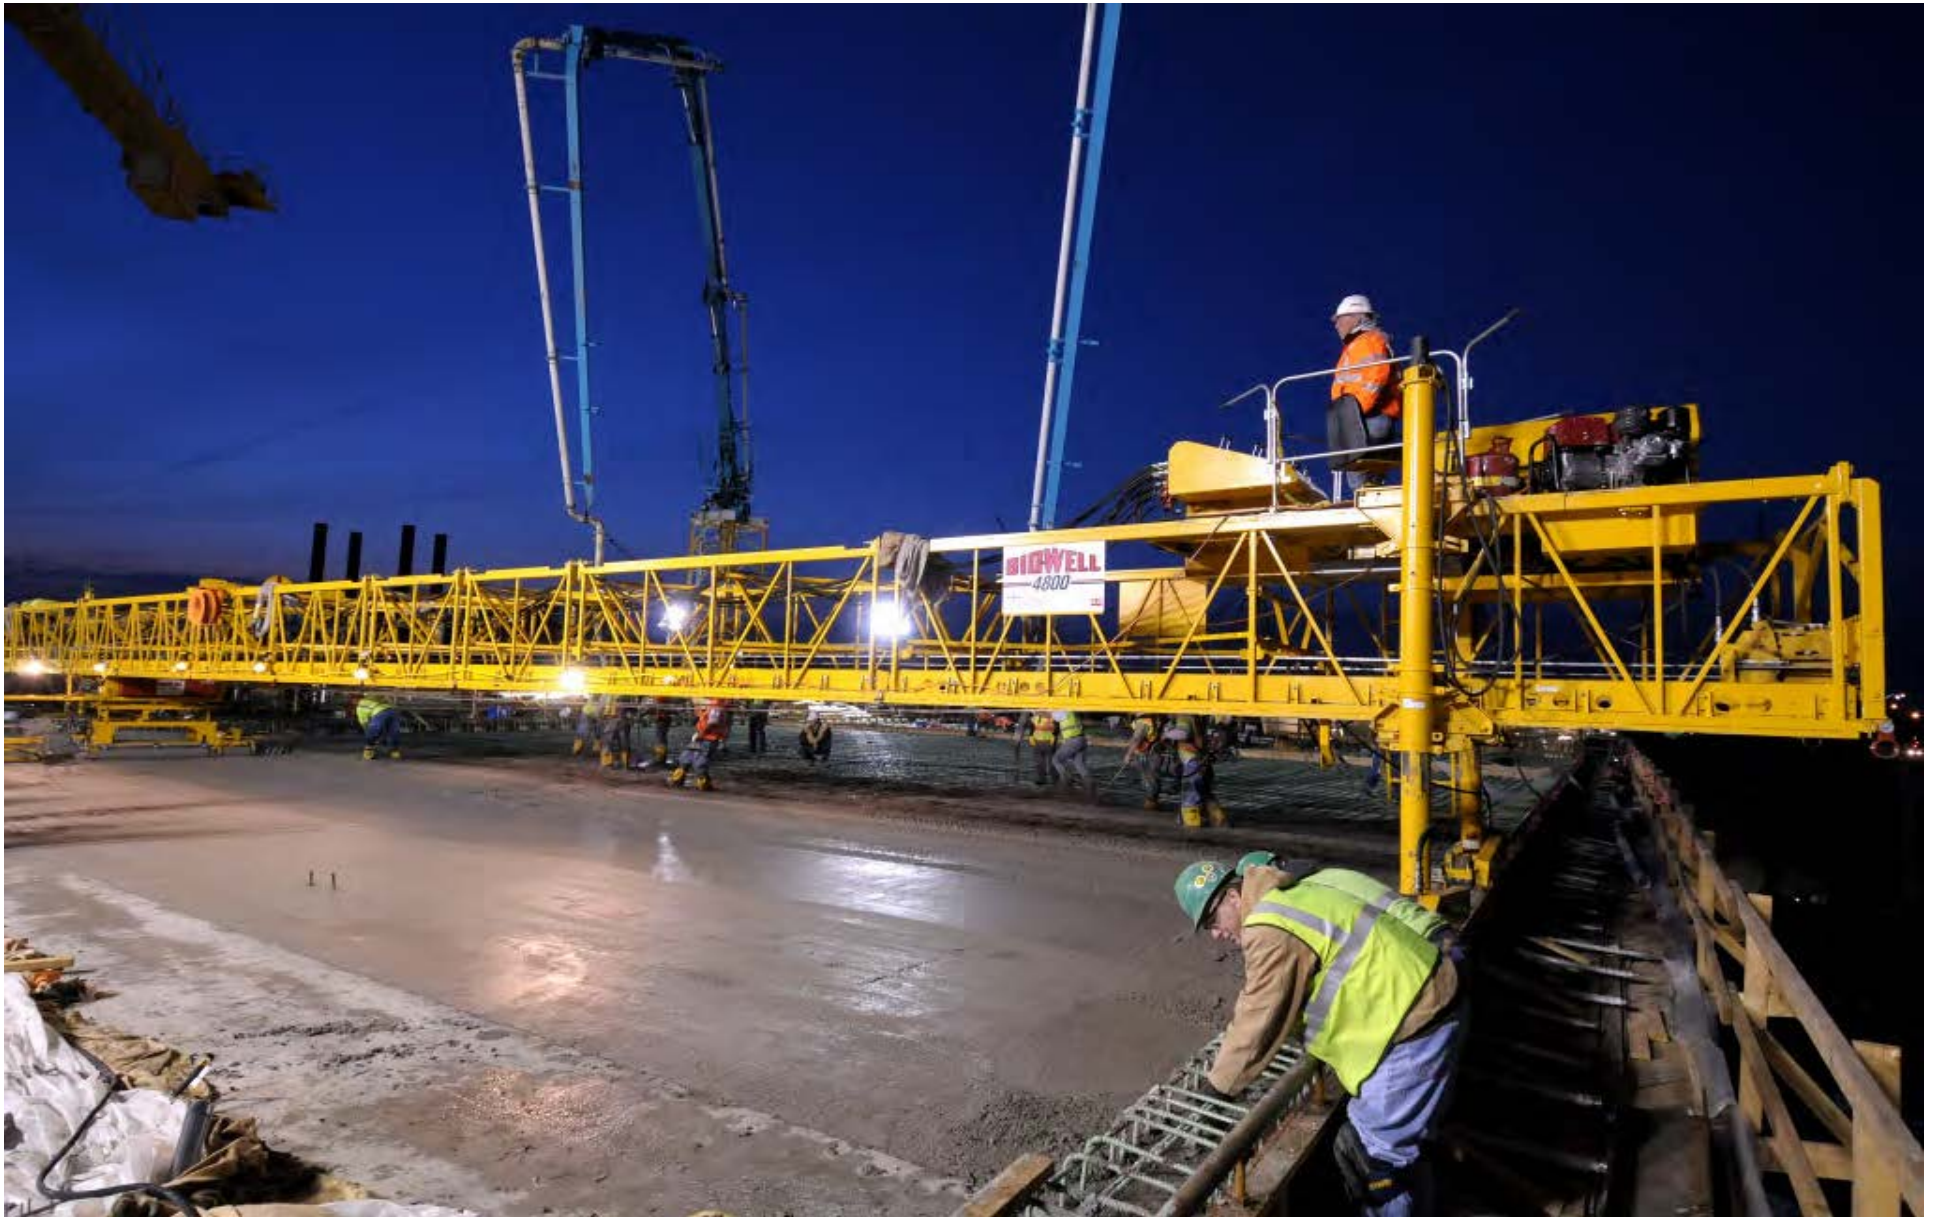
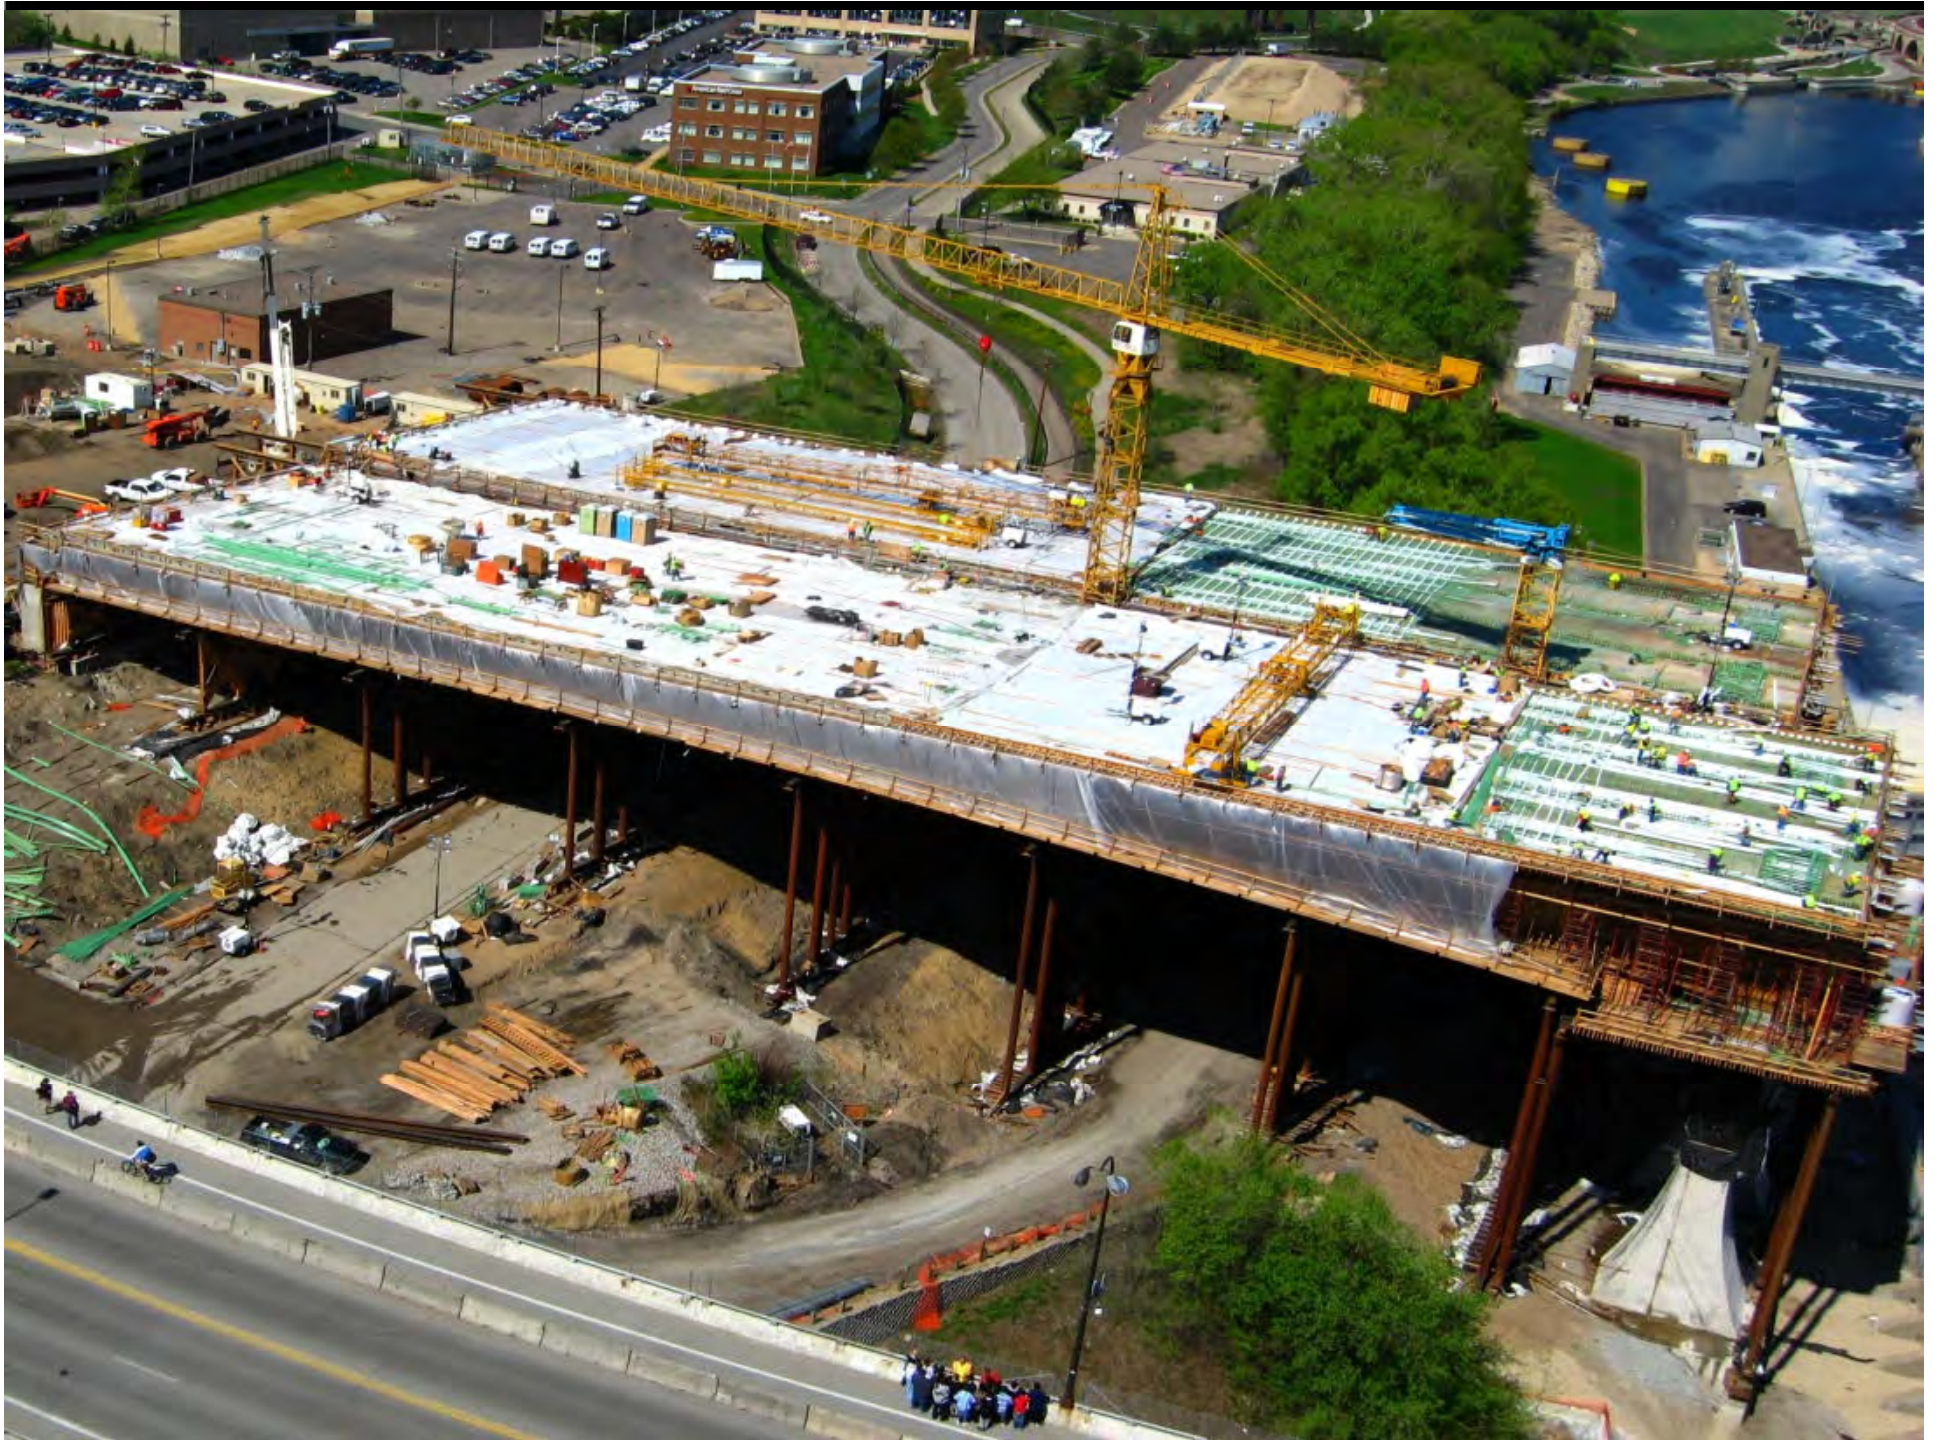
Elevation of Long-Line precasting system

Precast Span 2 Segments Off-Site

Phase 7

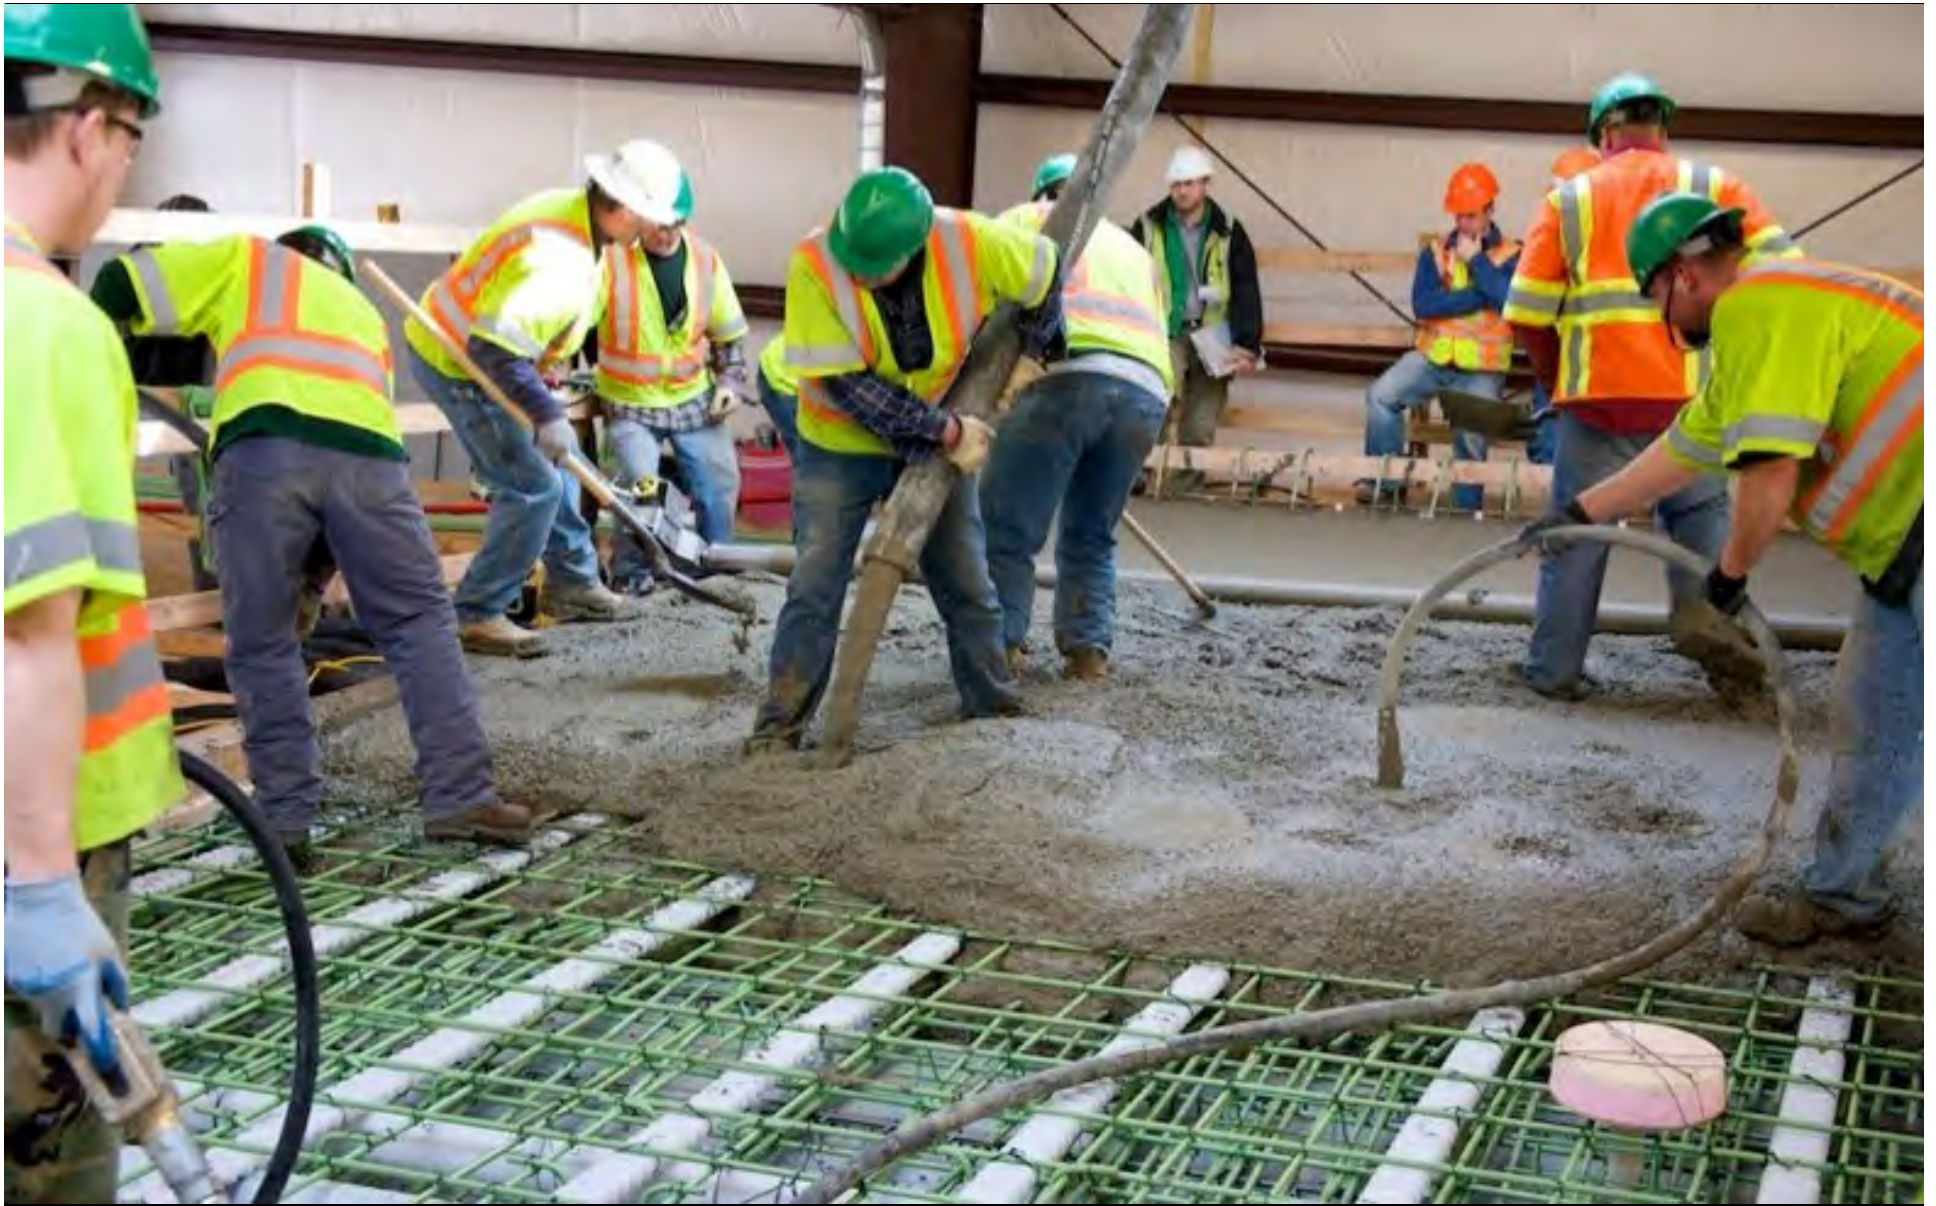
Pre-cast segment work

Pouring top slab, road bed, first segment, Feb. 19, 2008

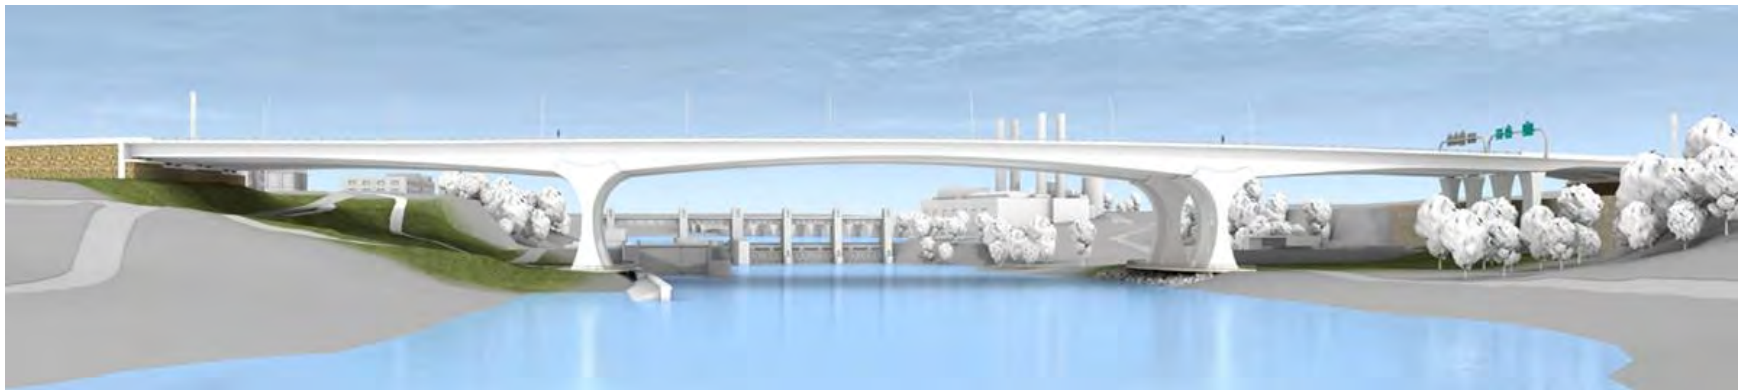
“Smart Bridge” System

Integrated Bridge Sensor Monitoring System covering five areas:

- Support construction processes
- Record of structural behavior (structure monitoring)
- Control of the automated anti-icing system
- Intelligent Transportation System (ITS)
- Bridge security

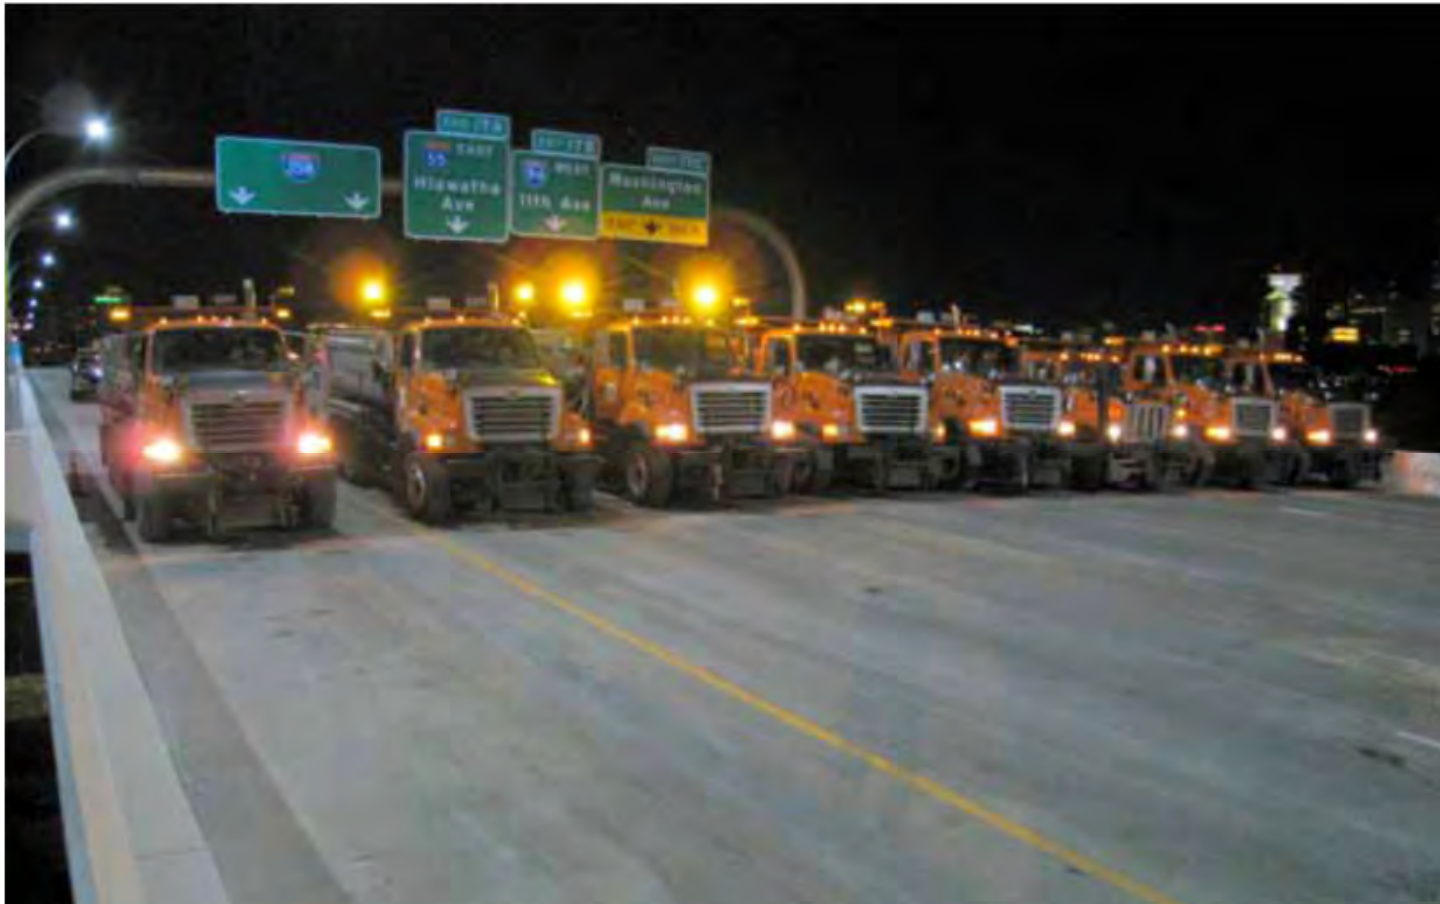
Load Calibration of Sensors

8 Trucks @ 25 Tons Each
